# Lessons Learned Through Evaluation of a Road Construction Failure in Compressible Soils, Lindberg Road Improvement Project, West Lafayette, Indiana

Terry R. West, Ph.D., P.E., CPG  
Professor of Engineering Geology  
Earth & Atmospheric Science Dept.  
Purdue University, West Lafayette, Indiana

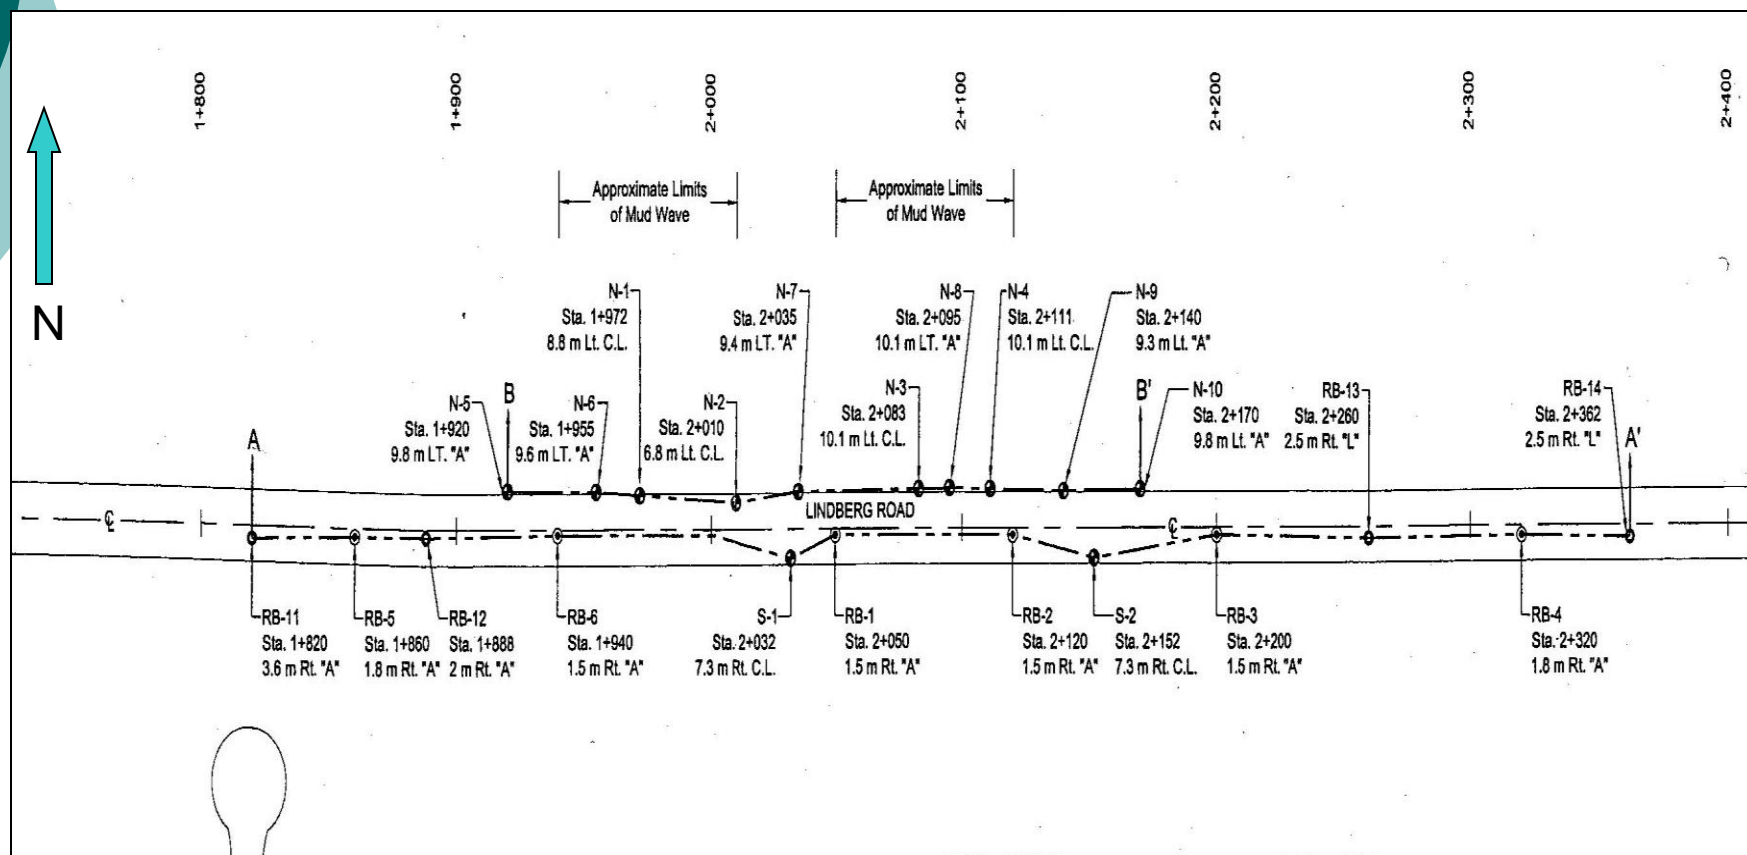
- April 2002: Bernardin Lochmueller hired to replace Woolpert (project mgmt.). Earth Exploration and Atlas Excavating were kept on for continuity.
- August 2002: ATC (geotech. consultant) hired to obtain additional data and evaluate failure.
  - Findings indicated that failure occurred in thickest section of marl (12.8').
  - Concluded that Auger Cast Concrete Pile Program with a geogrid below base course suggested by Earth Exploration would be satisfactory to stabilize area.
    - Piles should extend at least 9.8' (3m) into silty clay soil.
    - Soils in vicinity were marginally stable and no soil filling should be accomplished without pile support.

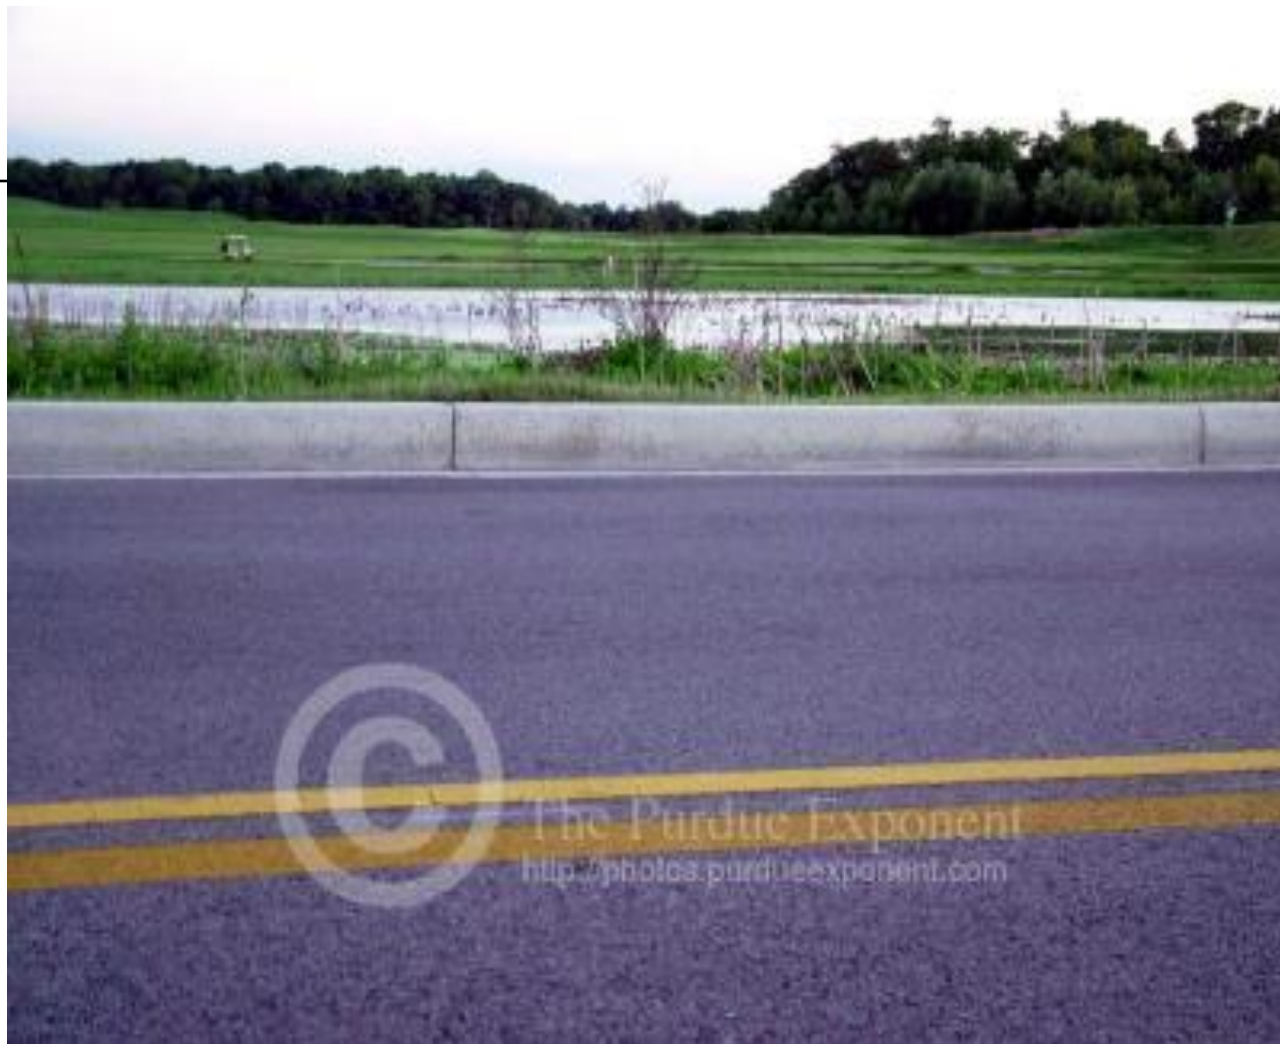
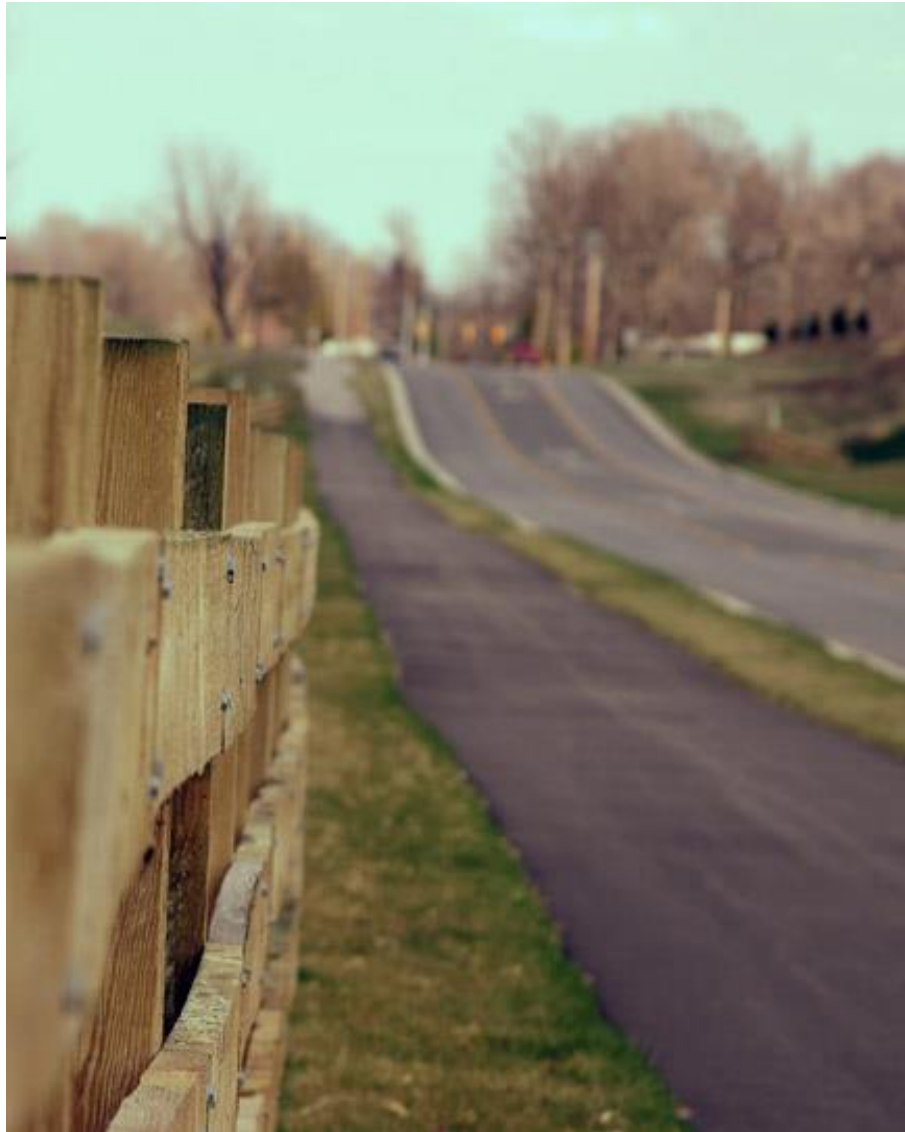
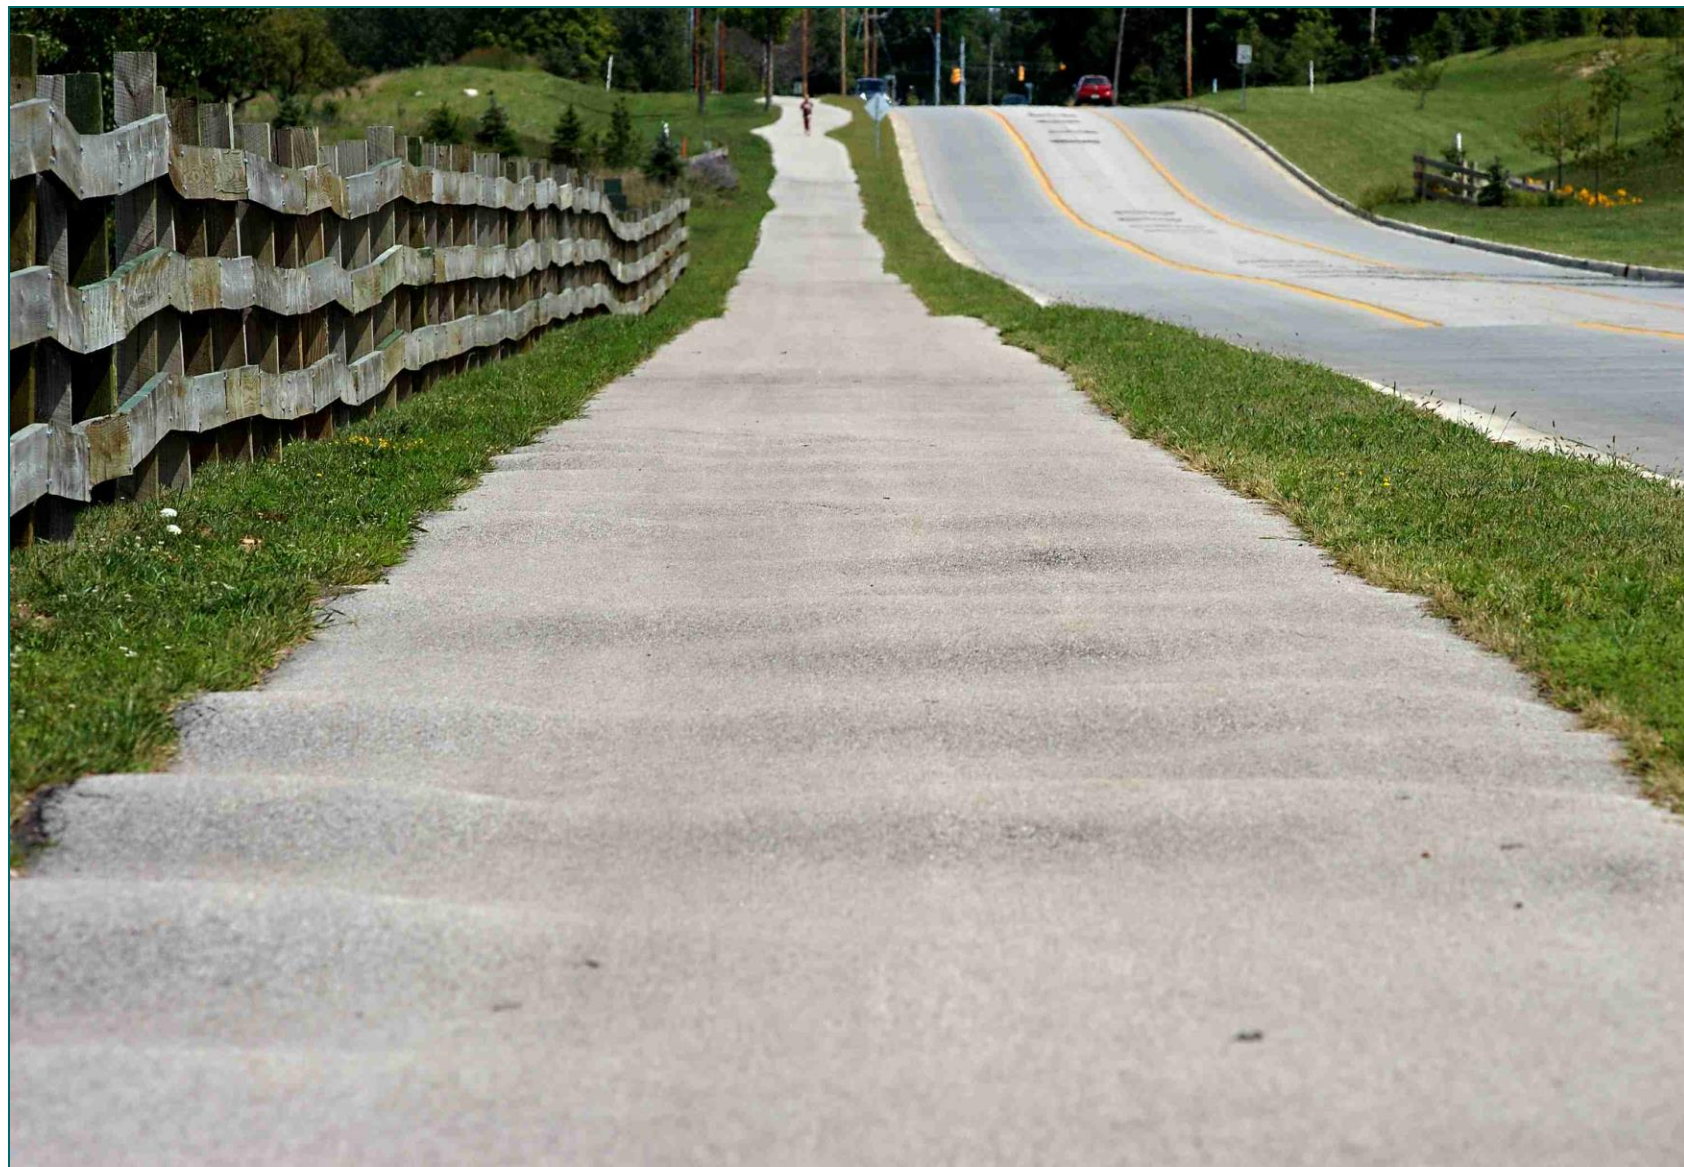
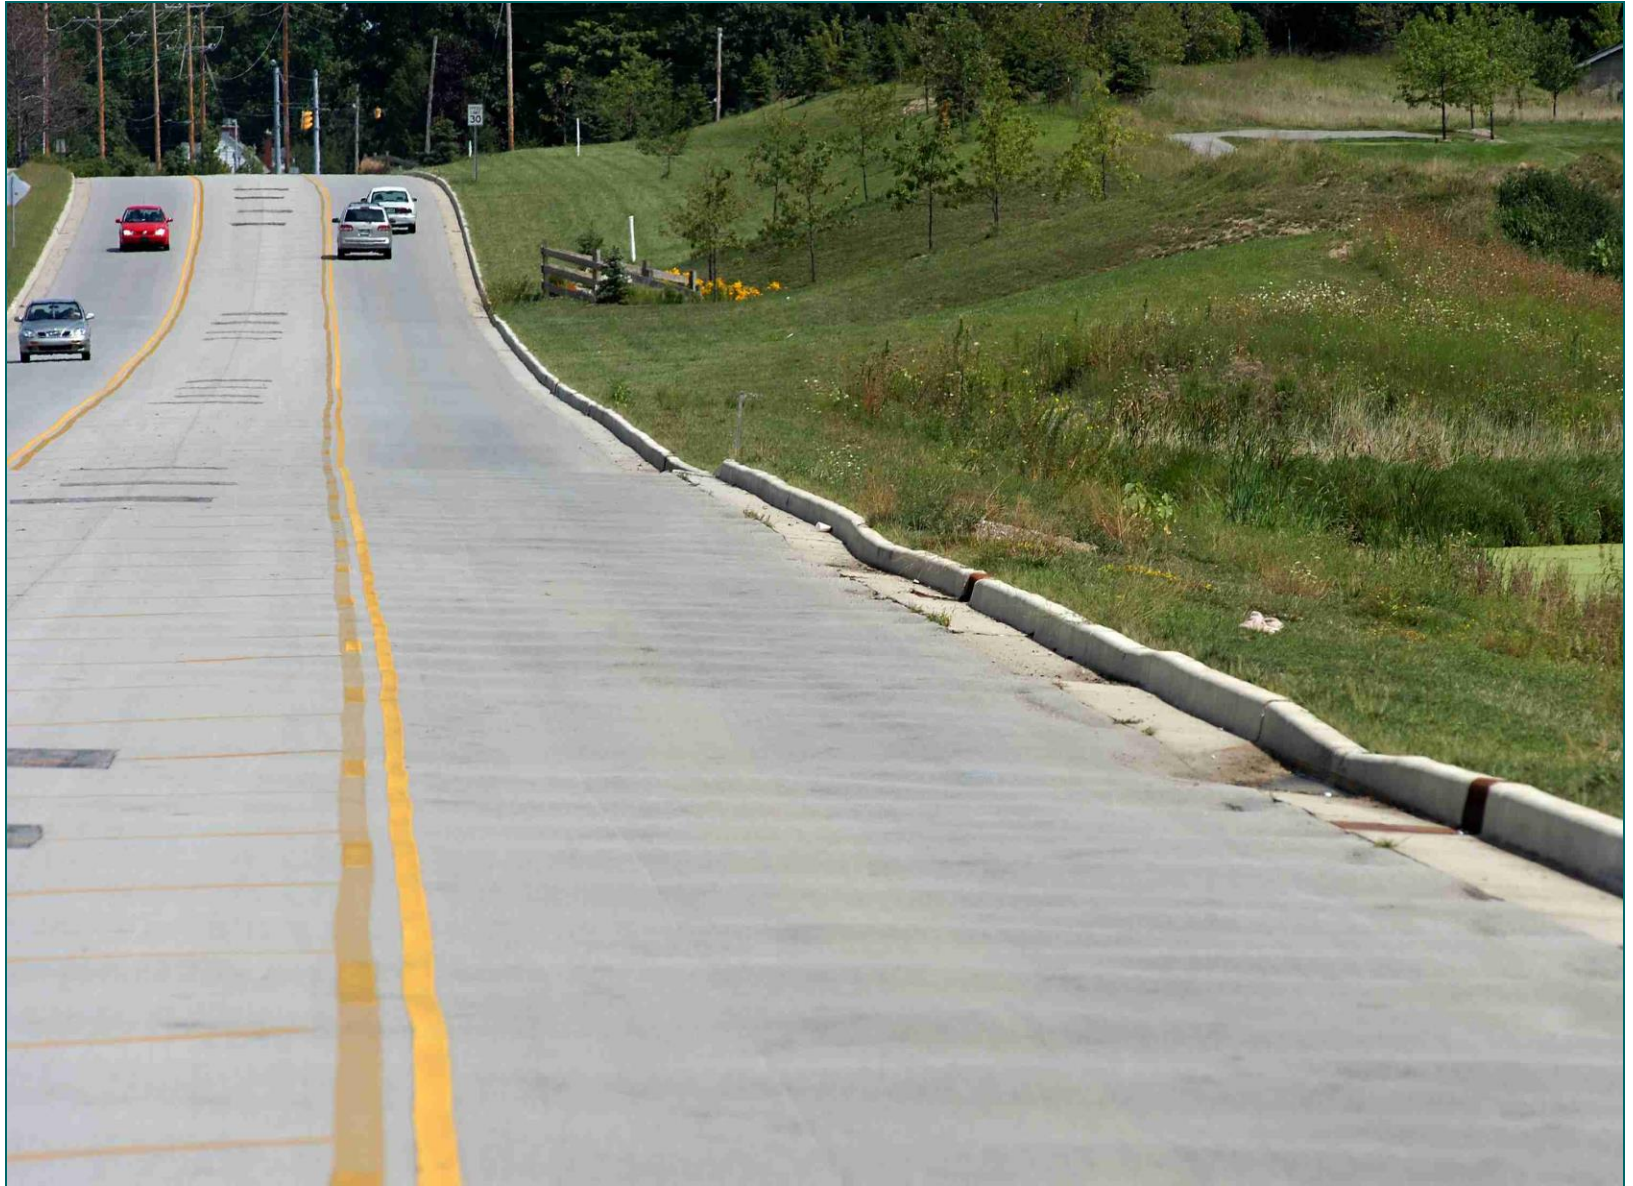
- Spring 2004: Project completed. Surface settlement begins almost immediately. Road resembles washboard.
  - Base course fails to transfer pavement loads to augered piles.
  - Pile system not extended for full length of bog yielding sizeable settlement on east side of construction project.
- Fall 2005: City re-paves roadway in attempt to smooth surface. Hoped added weight would provide greater stiffness and accomplish load transfer from base course to columns.
- Fall 2006: Settlement continues. City monitoring settlement and will drill borings through road to determine grid material and composition of base course.
