# Lessons Learned Through Evaluation of a Road Construction Failure in Compressible Soils, Lindberg Road Improvement Project, West Lafayette, Indiana

Terry R. West, Ph.D., P.E., CPG  
Professor of Engineering Geology  
Earth & Atmospheric Science Dept.  
Purdue University, West Lafayette, Indiana

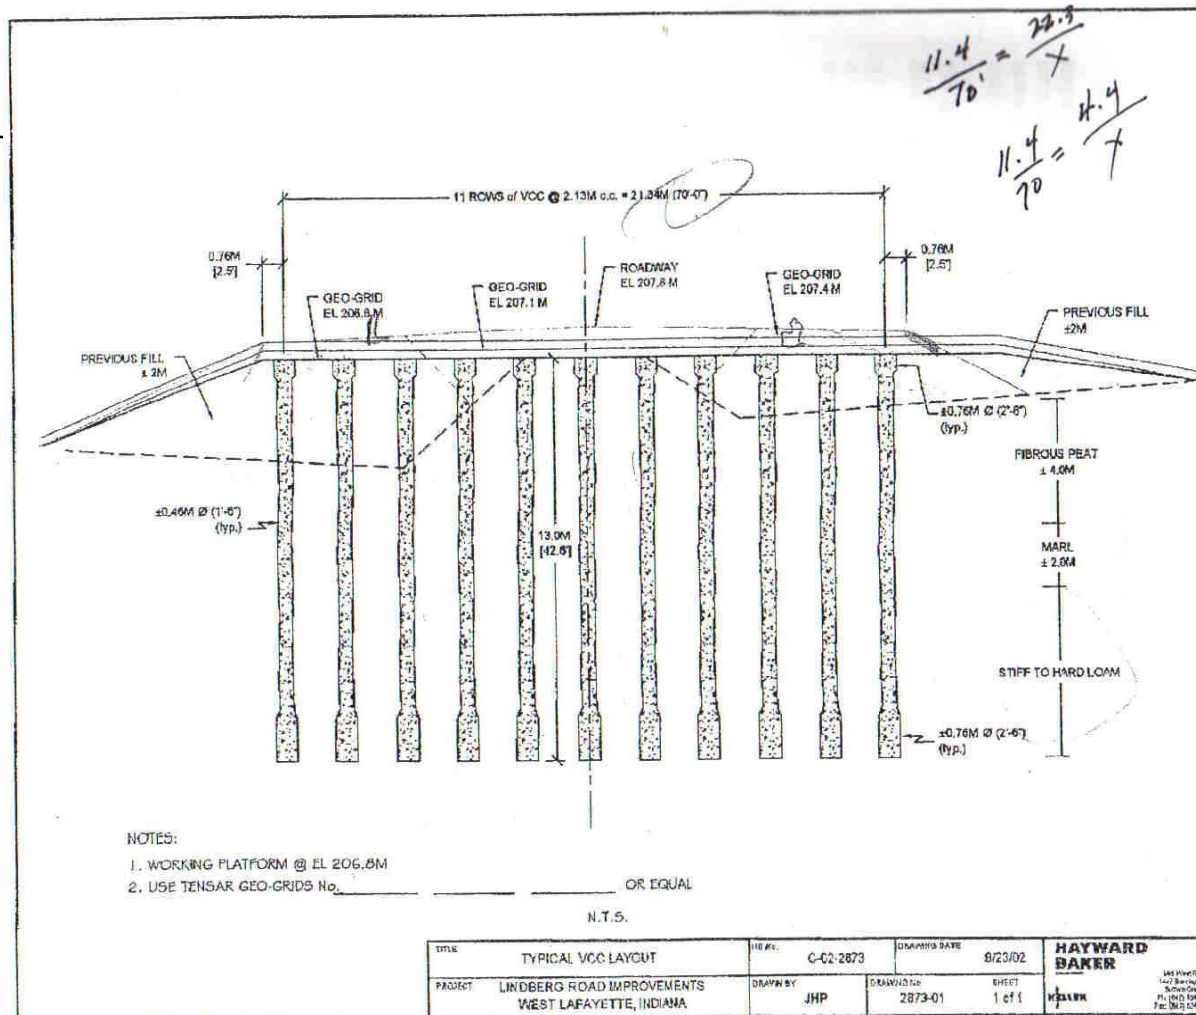
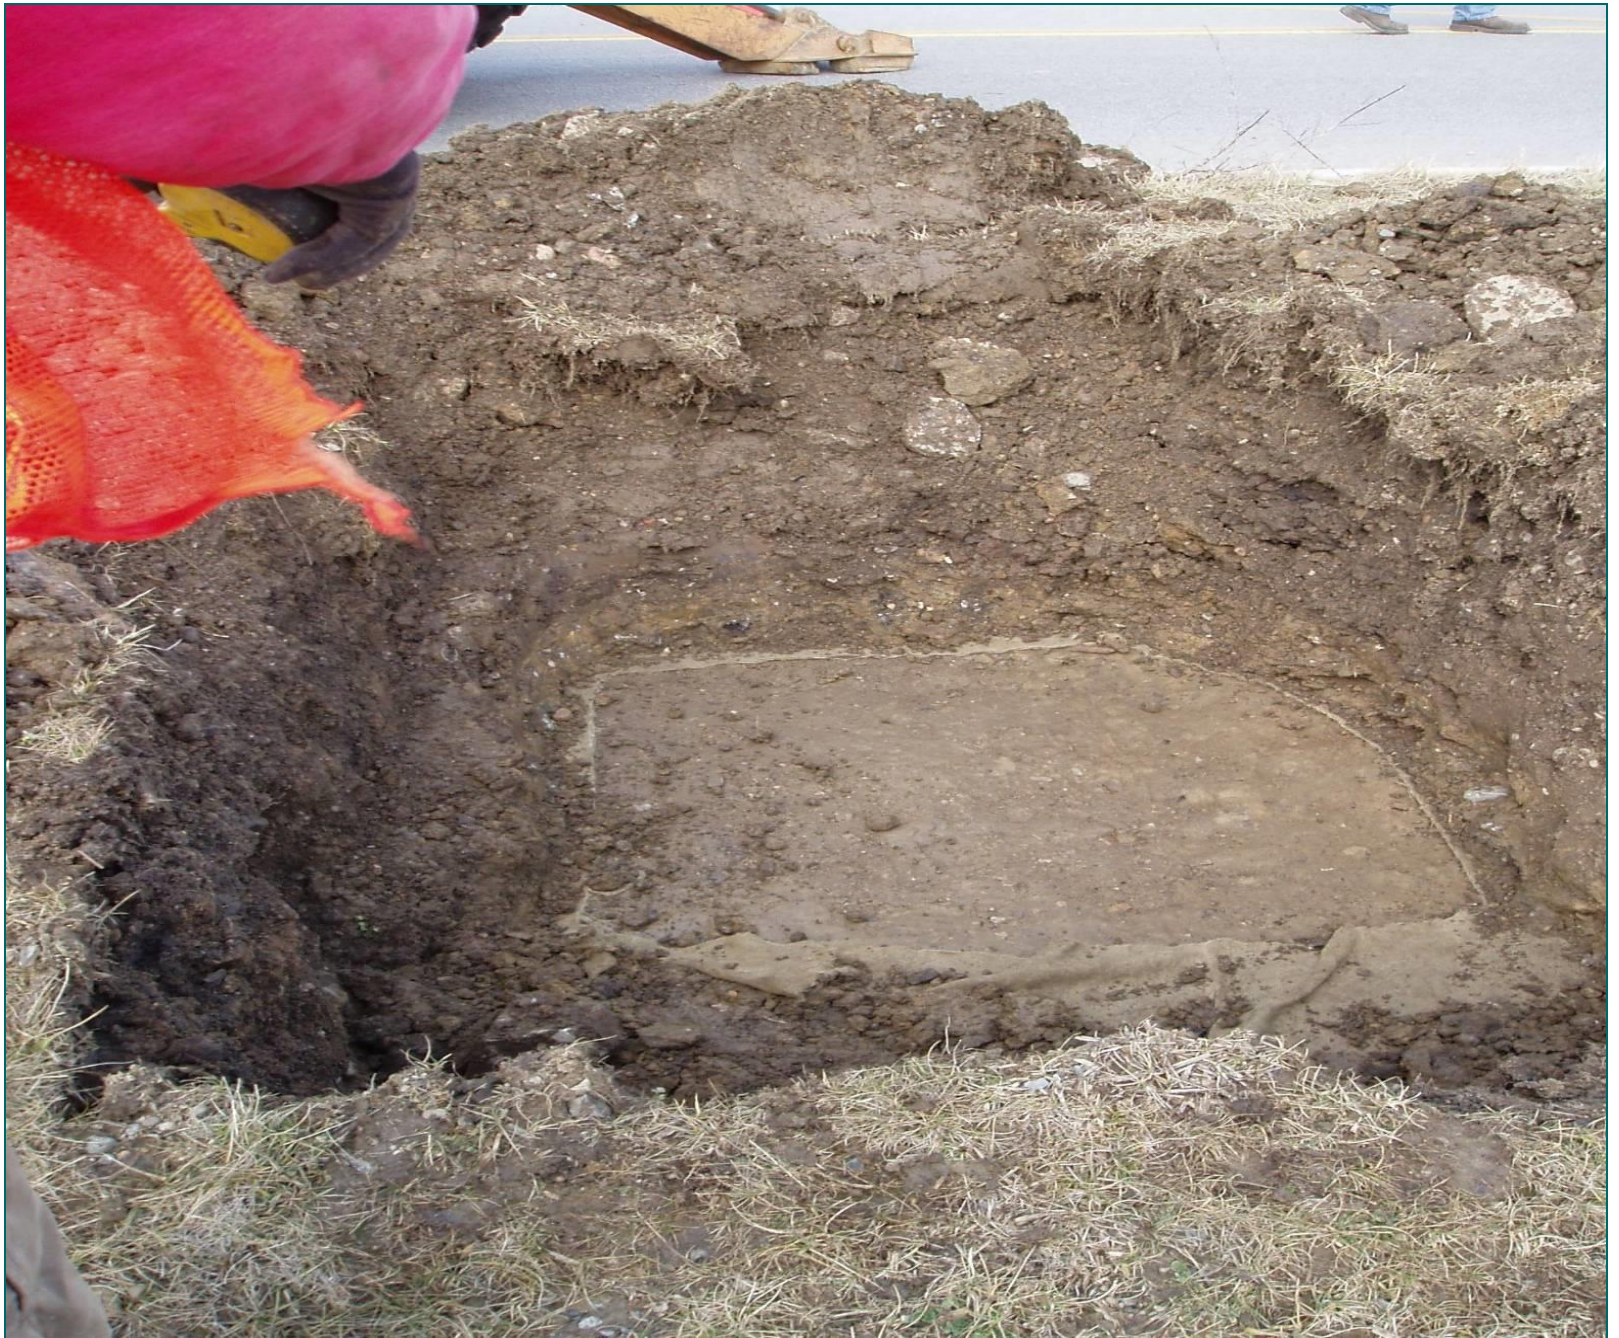
Figure 1: Primary Components of Platform System

- Spring 2004: Project completed. Surface settlement begins almost immediately. Road resembles washboard.
  - Base course fails to transfer pavement loads to augered piles.
  - Pile system not extended for full length of bog yielding sizeable settlement on east side of construction project.
- Fall 2005: City re-paves roadway in attempt to smooth surface. Hoped added weight would provide greater stiffness and accomplish load transfer from base course to columns.
- Fall 2006: Settlement continues. City monitoring settlement and will drill borings through road to determine grid material and composition of base course.
